# City of Tarpon Springs, Florida

## REGULAR SESSION AGENDA AGENDA MONDAY, MARCH 4, 2024 6:30 PM - City Hall Auditorium

### ADAPTATION AND RESILIENCY PLAN FOR THE HISTORIC DISTRICT AND GREEKTOWN

MINUTES\*  
HERITAGE PRESERVATION BOARD  
CITY OF TARPON SPRINGS, FLORIDA  
REGULAR SESSION – FEBRUARY 5, 2024

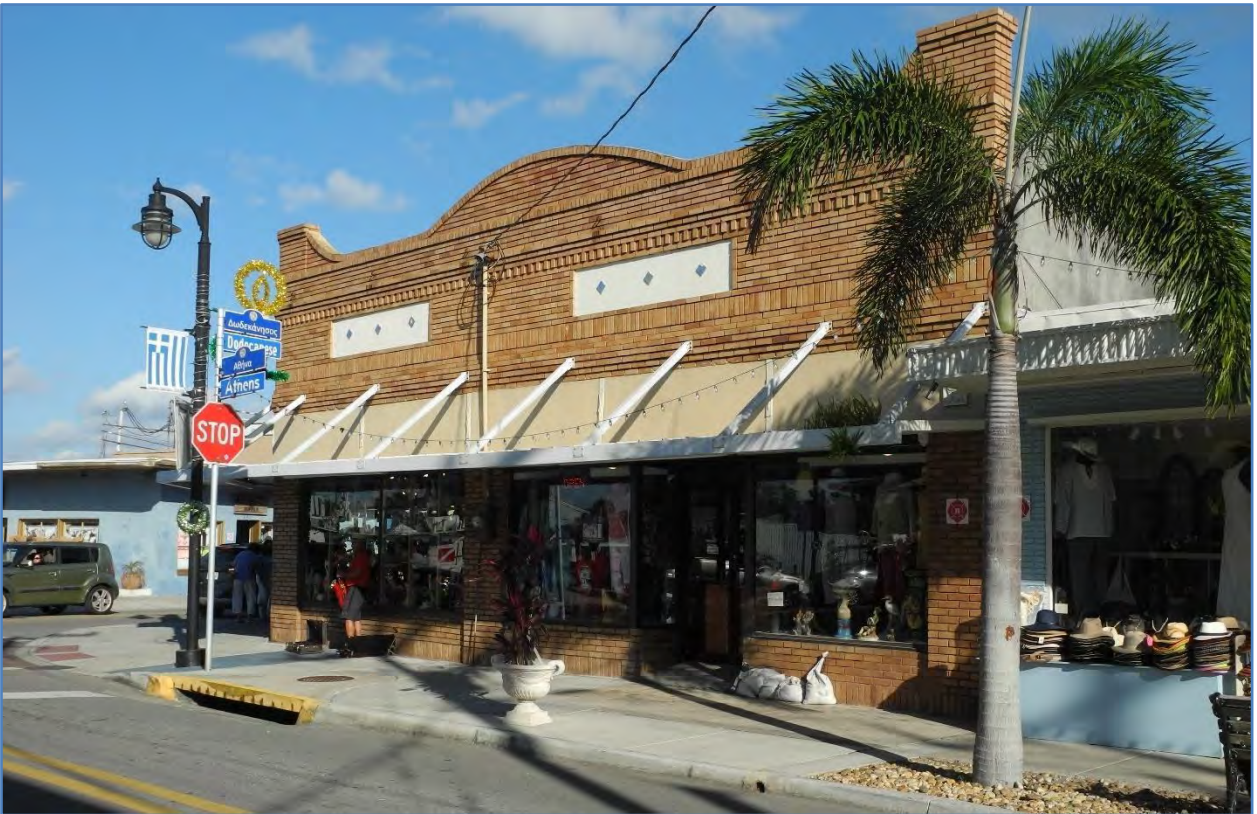
Figure 6. Ganatos Building (1925) at corner of Dodecanese Boulevard and Athens Street, 2022 photo.

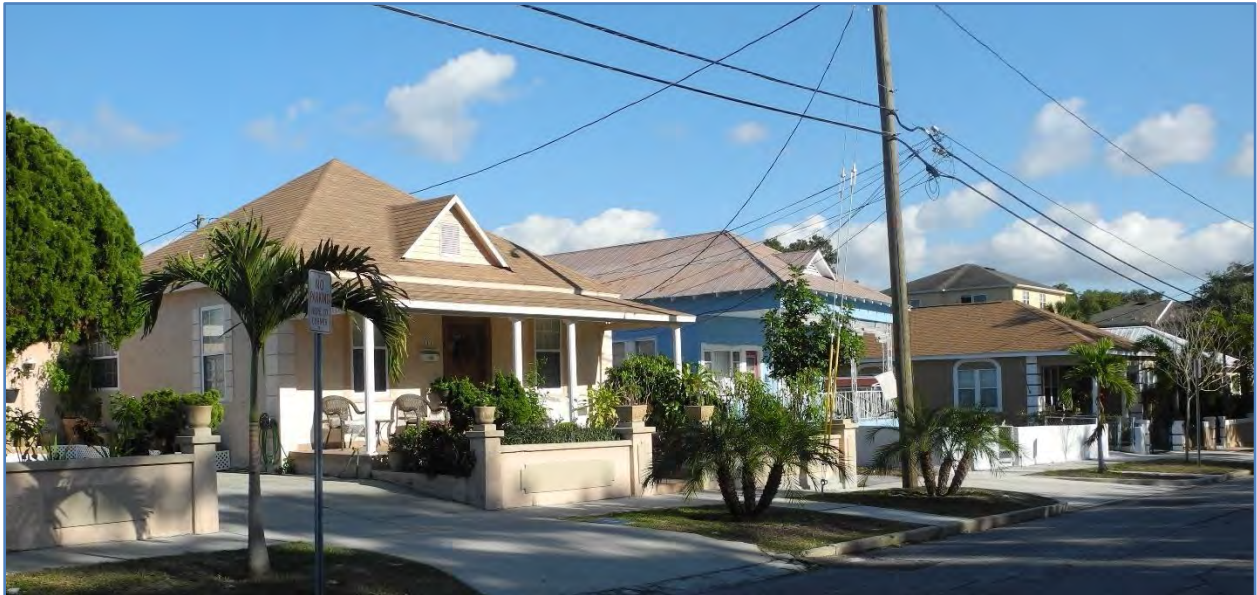
The rest of the Greektown area consists mostly of residential, single-family occupancy. Many of the homes date from the period of the 1920s, built from wood frame construction in the Frame Vernacular and Bungalow **architectural styles** (Figure 10). These structures are typically elevated several steps above the adjacent land on piers with wood frame floor systems. A characteristic feature of many properties is the use of low masonry garden walls (also called “site walls”) that define the property edges.

Figure 10. Typical residential area structures in Greektown with low garden walls, 2022 photo.

Site infrastructure of historic significance in Tarpon Springs often includes “site walls” or “garden walls” (Figure 10) that are **contributing** in their own right. These features may take the initial force of advancing water on a property, thereby providing some functional level of diversion/protection. Other common site features include fences, landscaping/gardens, walkways, driveways, and other improvements. Buried infrastructure most often includes structural footers/pilings and buried utilities. Like foundations, site infrastructure is at risk of exposure to damage from water movement and soil erosion or shifting.

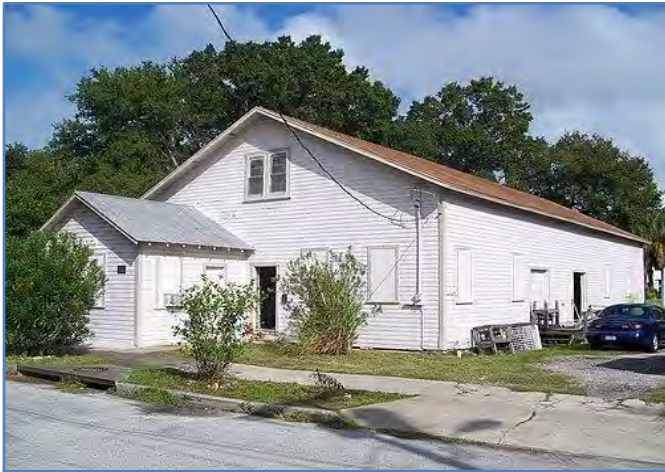
- N. G. Arfaras Sponge Packing Plant (**Florida Master Site File (FMSF) #8Pi1545**), a wood frame building with drop siding at 26 West Park Street (Figure 11) built in 1930. ([NR#91000412](#), listed 1991).
- E.R. Meres Packing House (FMSF #8Pi1594), a wood frame building at 106 West Park Street. Built in 1905, it is the oldest extant example of a sponge packing warehouse ([NR#91000411](#), listed 1991). It is a wood frame packing house, clad with corrugated metal (Figure 12).
- One historic sponge boat is also individually listed, the N. K. Symi.

Figure 11. N.G. Arfaras Packing House, 2022 photo.

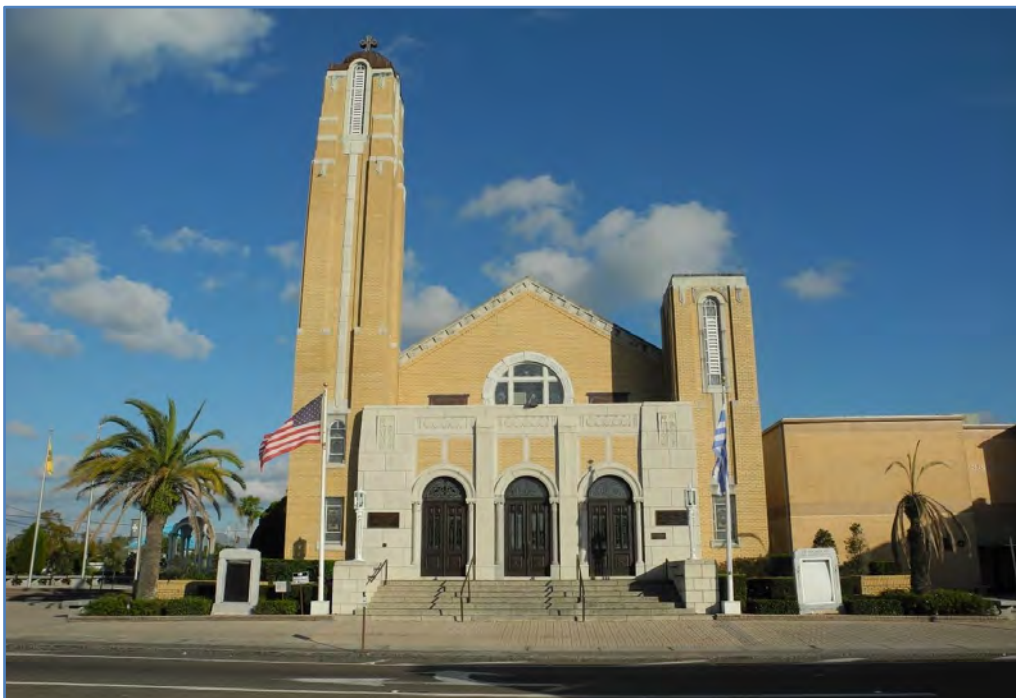
The St Nicholas Greek Orthodox Church (FMSF #8PI1563), 348 N. Pinellas Avenue (Figure 13), was identified as being potentially eligible for individual listing on the NRHP under criterion A.<sup>6</sup> Built in 1943 from brick masonry, the building is internationally acknowledged as a fine example of the Neo-Byzantine style as applied to a Greek Orthodox Church, and retains a high level of architectural integrity. The parcel, containing the cathedral, plaza and related buildings, is located on a high point of elevation along North Pinellas Avenue and is an iconic symbol of Tarpon Springs.

Figure 13. St. Nicholas Greek Orthodox Church, 2022 photo.

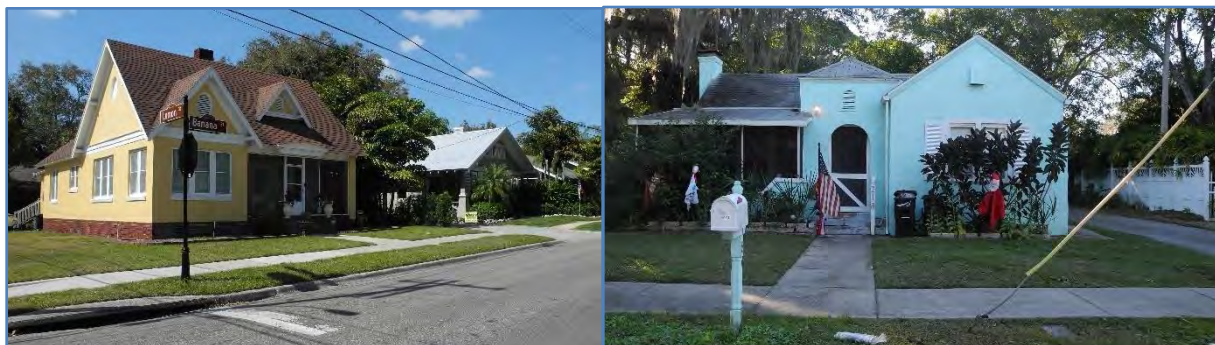
Figure 17. Masonry and wood frame houses in the Fruit Salad neighborhood, 2022 photos.

On the west side of the **Local Historic District** is the area known as the “Fruit Salad” neighborhood, where the streets are named for tropical fruits. This area partially overlaps the southern section of the Greektown National Register District. The character of the neighborhood is defined by the rich collection of historic structures (Figure 17), the manicured landscape features, and the engineered infrastructure around the area of the Spring Bayou basin and Coburn Park (FMSF #8PI1907), which was renamed Craig Park in 1978.

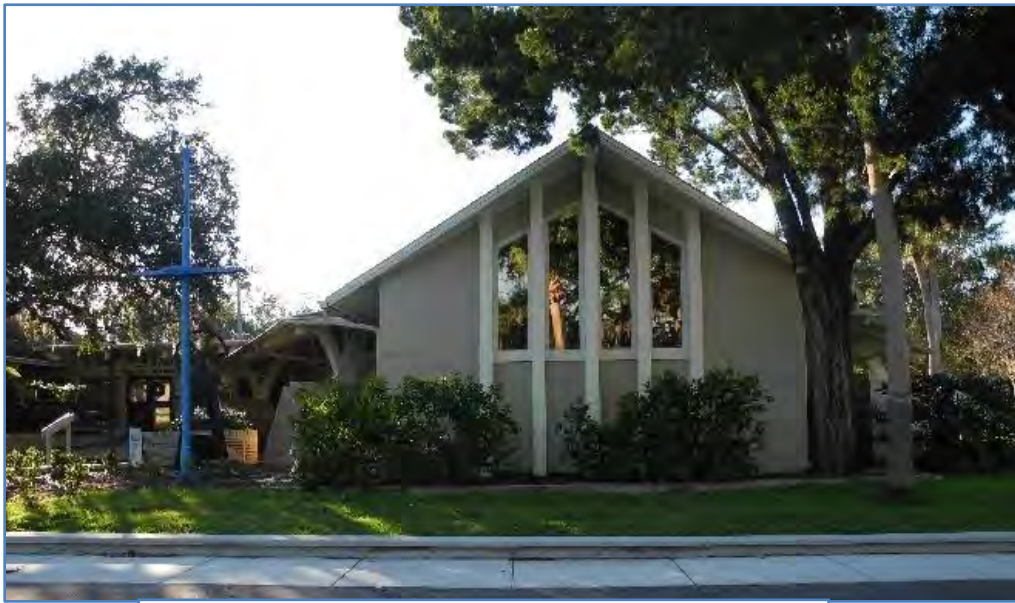
Figure 20. Craig Park Heritage Museum, 2022 photo.

While the former 1966 Library building was not included in the 2009 Historic Survey Report, as it was outside of the **Local Historic District's period of significance** (1881 – 1959), remnants of the mid-century structure are still discernible after adaptive reuse of the building for the Tarpon Springs Heritage Museum (Figure 20).

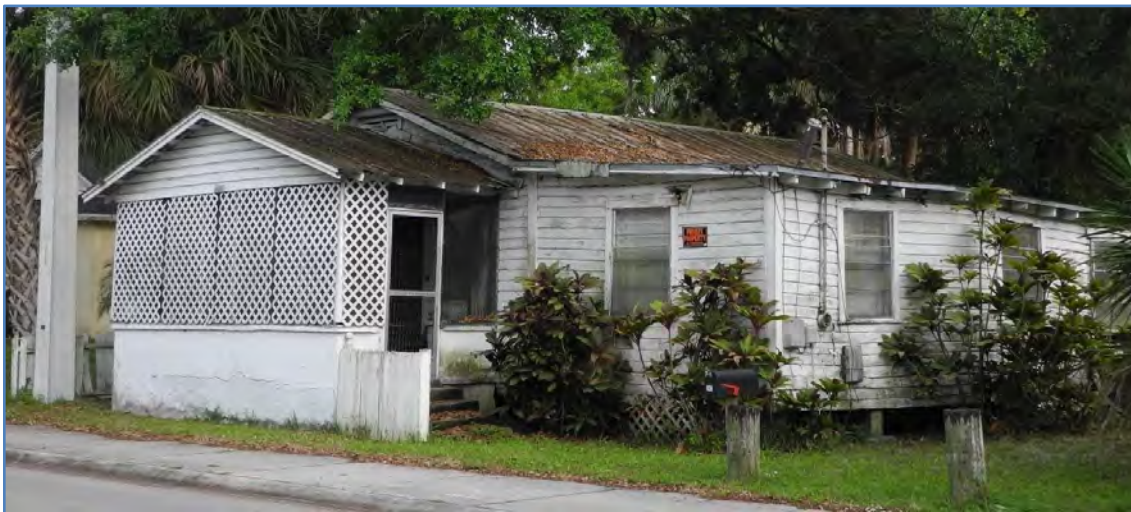
Figure 21. Reported former World War II barracks now used for residence on East Martin Luther King, Jr. Drive., 2022 photo.

The built heritage assets consist primarily of small, wood-frame, vernacular residential structures (Figure 21). The community also features supporting assets that house spiritual, commercial, and educational functions, some constructed from wood frame and some masonry structures (Figures 22 and 23).

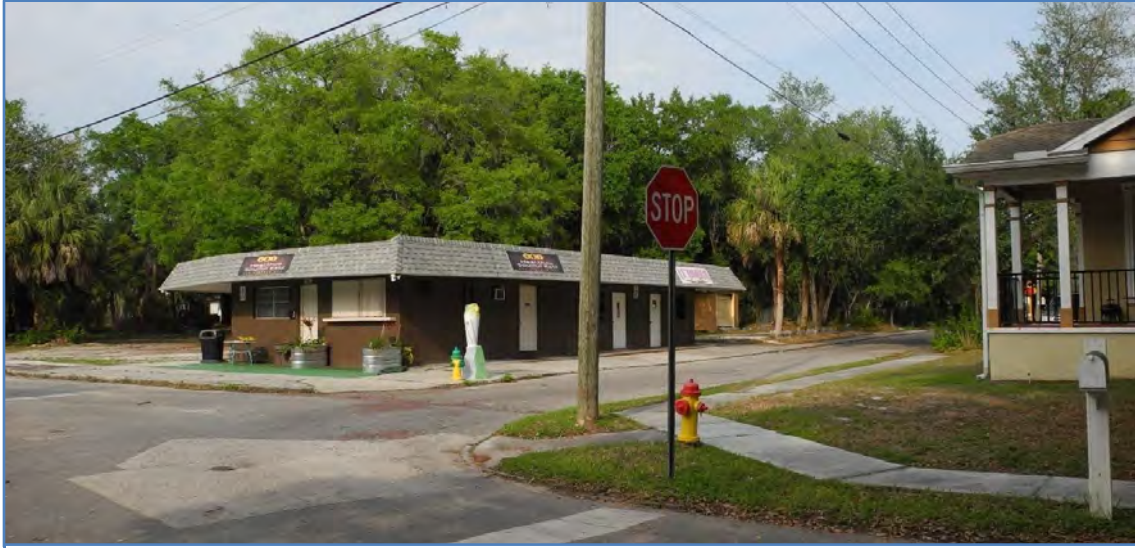
Figure 22. Masonry commercial “corner store” building in Union Academy, 2022 photo.

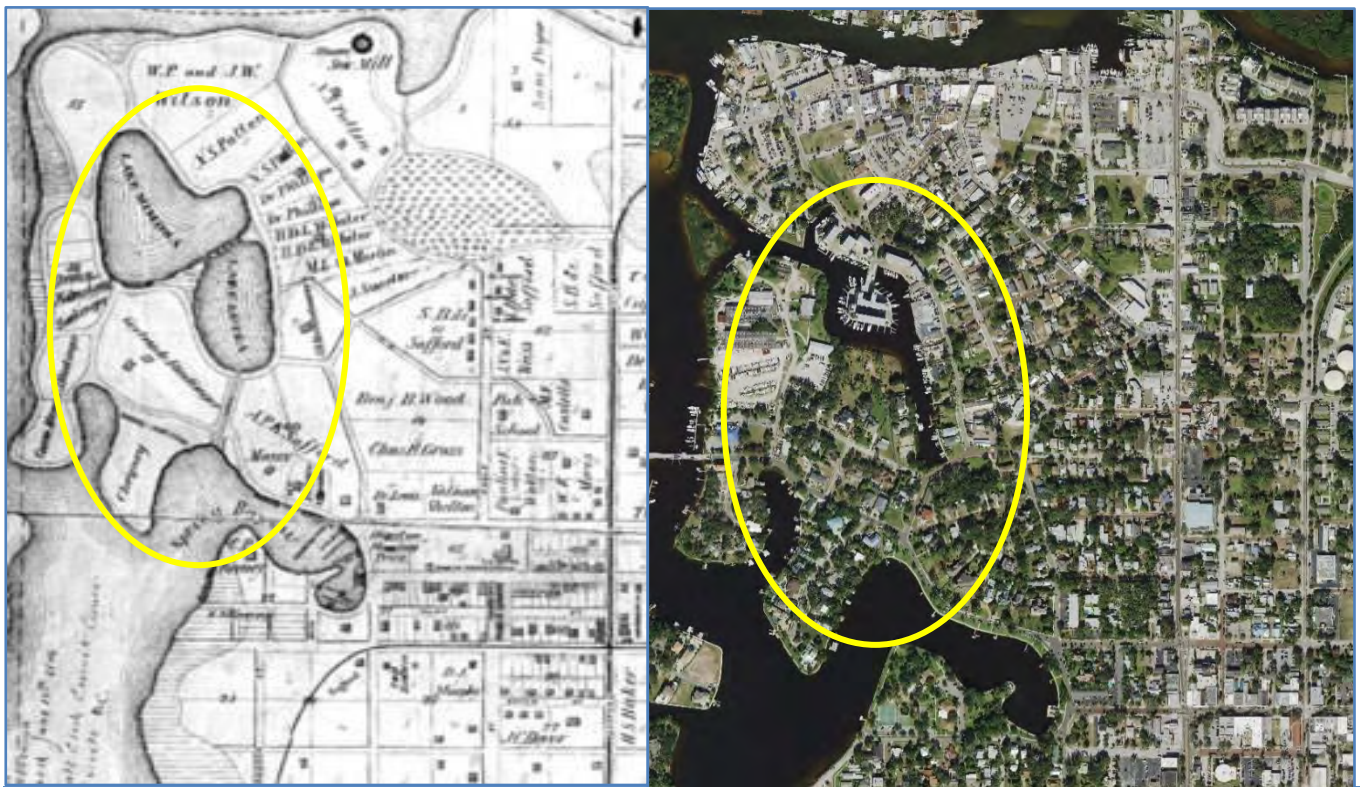
Figure 24. 1883 plat map of Tarpon Springs showing earlier configuration of Spring Bayou and connected lakes in the area now known as “The Canal” (State Archives of Florida, Florida Memory accessed July 1, 2022 <<https://www.floridamemory.com/items/show/5305>>).

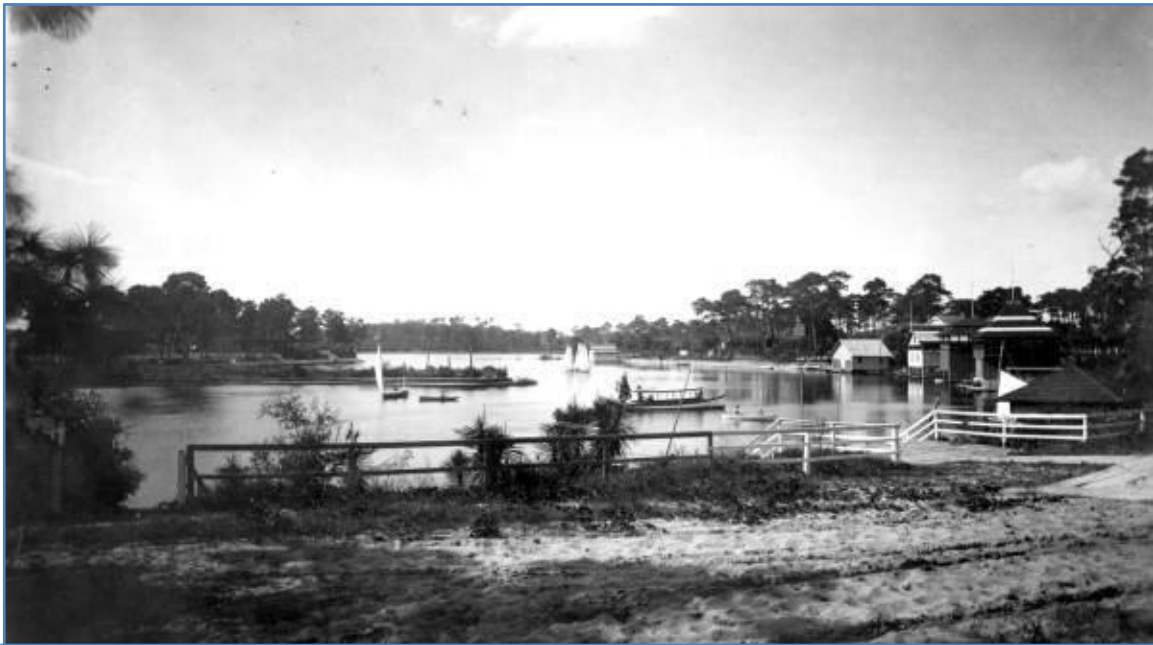
Figure 28. Looking west at Spring Bayou from Switzers – Tarpon Springs, Florida, c.1890.

The “Fruit Salad” and Spring Bayou neighborhoods occupy another area that experienced significant topographic alteration in the past. The 1883 town map shows the area of lowlands that likely consisted of herbaceous and forested wetlands prior to alteration (Figure 27). A photograph taken in approximately 1890 shows the more natural shoreline condition from a vantage point looking west across the bayou (Figure 28). The photograph in Figure 19, taken in approximately 1900 shows some of the infrastructure improvements made to the basin with seawalls creating hardened edges and land built up behind them. Significant land building in the neighborhood via dredge and fill behind perimeter bulkheading is clearly visible on today’s aerial photography. Appendix A, Map 5 shows the SFHA coverage of this area. Current land elevations across much of the “Fruit Salad” area west of Banana Street are less than four feet above **sea level** (Appendix A, Map 10). Sunny day flooding now tops the Spring Bayou seawall at Craig Park. Along the eastern edge of Spring Bayou, the historic houses of the Golden Crescent are on a natural elevated ridge that is still above the SFHA elevation, but as one continues to travel north, the elevation drops back down in the Read Street/Parkin Court area.

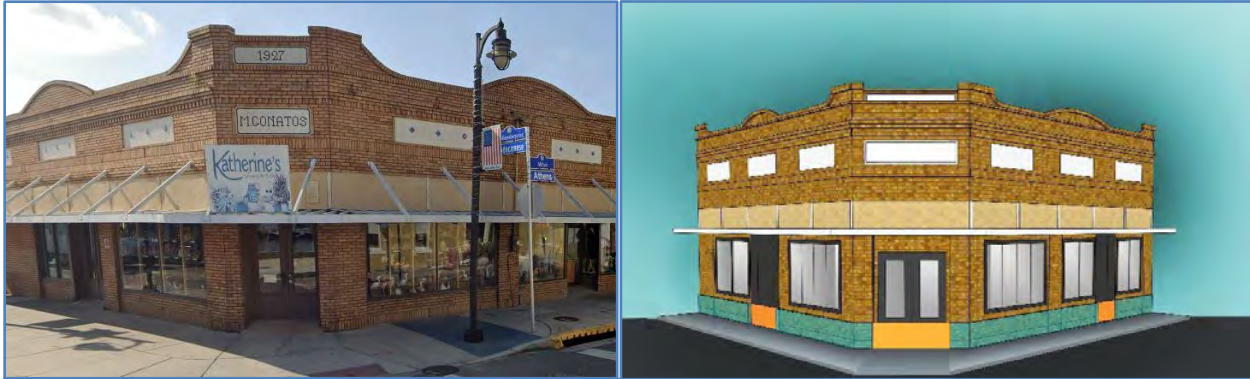
Figure 37. Temporary protective measures using floodgates and flood-wrapping for single story commercial: Gonatos Building, 628 Athens Street.

The Gonatos building (ca. 1927) located at the corner of Dodecanese Boulevard and Athens Street is typical of masonry commercial structures with finished floors below the **base flood elevation** (Figure 37). This roadway intersection floods, sometimes heavily, from **storm surge**, rainfall and high tide events. Installing **floodgates at the entry ways, and temporary flood-wrapping** of these single story shops is a good way to implement flood mitigation, while causing little impact on the aesthetics of the architectural elements.

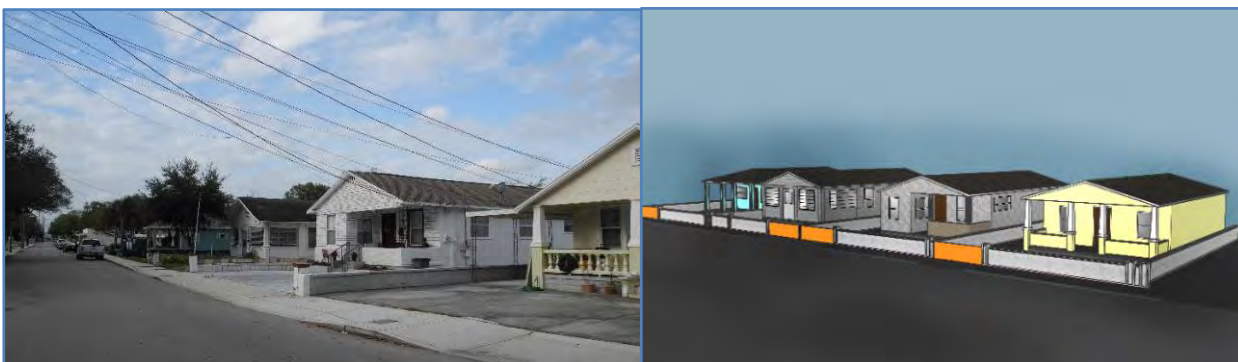
Figure 40. Streetscape at 120-126 Athens Street, illustrating potential coordinated protection using permanent garden walls and floodgates.

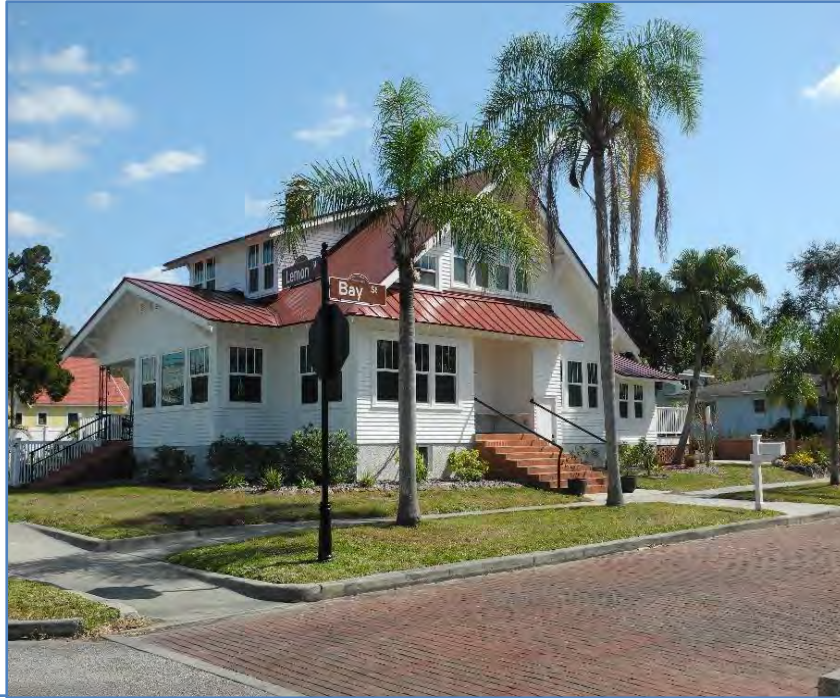
Figure 43. The home at 201 Bay Street is elevated on a continuous brick foundation wall and includes a basement. The elevation well above grade is emphasized by the long staircases leading into the front and sides of the structure.

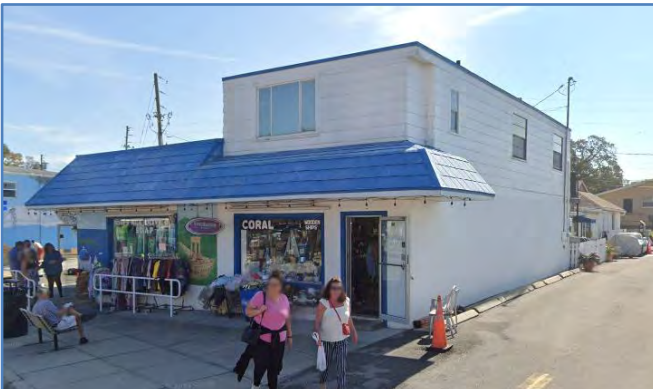
Figure 48. The structure at 805 Dodecanese Boulevard is a mixed use building designed to place living area on the second floor above the expected flood elevation. This approach can include permanent floodproofing measures or temporary protective floodgates and flood-wrapping, as illustrated.

This approach uses multiple stories of a building to locate or relocate living spaces to floors above the flood risk level. Several Greentown structures such as the shop located at 805 Dodecanese Blvd (Figure 48) were originally designed as mixed use units with living spaces on the second floor. As illustrated by this building, the method is best adapted to buildings with ground floor spaces of masonry construction. This method may involve complete abandonment of the lowest floor and removal of all conditioned space. In that case, the floor may only be used for parking, storage and building access. However, if the goal of the project is to bring living area above the appropriate finished floor elevation, the lowest floor need not be completely abandoned and can now be floodproofed because it is no longer used for living space. An exterior method of egress should be available from the second floor to utilize for emergency exit if flood waters or **floodproofing** measures prevent safe exit out the main entrance on the ground floor.

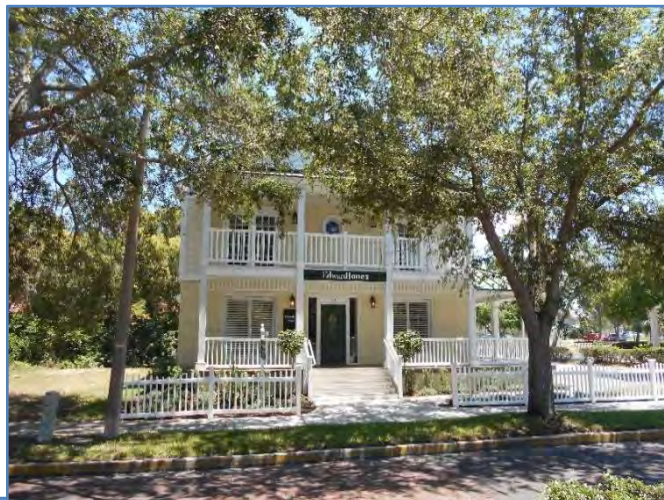
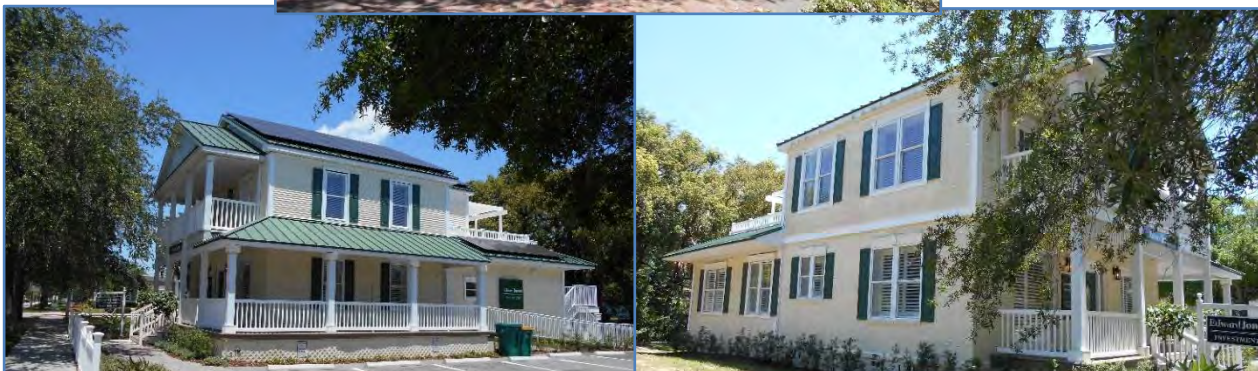
Figure 49. The office of Edward Jones financial advisors is an adaptive reuse of a residential structure (ca. 1936) that was moved in 2001 from the AE Flood Zone to North Safford Avenue, outside the floodplain. Note the landscaping and low-rise steps that soften the building's new foundation.

Moving a historic building requires separating the building from its foundation and relocating it to a new site and foundation. The new site would ideally be outside a **flood zone**, or the new foundation would raise the building above the expected **flood elevation** (but see *Elevate the Building on a New Foundation*, above). The building must be strong enough to withstand the travel required to relocate it, as in the case of the house located at 22 North Safford Avenue (Figure 49). This residential structure that has been adapted to office space was relocated outside the **floodplain** from its original location in the **AE Flood Zone**. The building consists of a mix of construction materials (frame and block/brick) with walls of approximately 11 inches in thickness (Robin Hancock, pers. comm.). The purpose of the relocation in this case was to make way for commercial development on the original parcel, but a major benefit of the move was relocation to an appropriate historical setting in the City's downtown outside the **floodplain**. Moving a building is physically and financially challenging. In Tarpon Springs, much of the City is in the **floodplain**, so appropriate sites that remove or reduce a building's exposure to flood risk are limited.
