TARPON SPRINGS ADAPTATION AND RESILIENCY PLAN FOR THE HISTORIC DISTRICT AND GREEKTOWN

**Linda Stevenson, AIA, University of Florida College of Design
Patricia L. McNeese, AICP, Planning Supervisor, City of Tarpon Springs**

September 2023

**TARPON SPRINGS ADAPTATION AND RESILIENCY PLAN
FOR THE HISTORIC DISTRICT AND GREEKTOWN
EXECUTIVE SUMMARY**

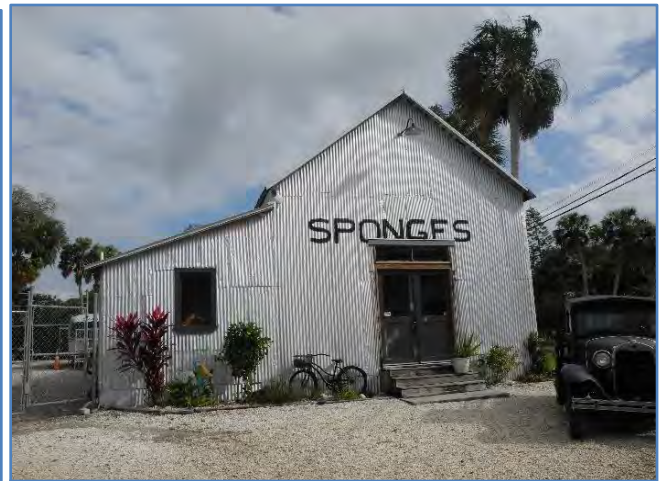
- N. G. Arfaras Sponge Packing Plant (**Florida Master Site File (FMSF) #8Pi1545**), a wood frame building with drop siding at 26 West Park Street (Figure 11) built in 1930. ([NR#91000412](#), listed 1991).
- E.R. Meres Packing House (FMSF #8Pi1594), a wood frame building at 106 West Park Street. Built in 1905, it is the oldest extant example of a sponge packing warehouse ([NR#91000411](#), listed 1991). It is a wood frame packing house, clad with corrugated metal (Figure 12).
- One historic sponge boat is also individually listed, the N. K. Symi.

Figure 12. Meres Packing House, 2022 photo.

Figure 31. The National Register building, “Meres Packing House” (see Figure 12) showing the general elevation of flood waters at one (green), two (orange) and three (red) feet above grade. This building has corrugated metal walls, a pier-supported foundation, and wood floor without a sub-floor. The ground elevation at this building entrance is less than three (3) feet above sea level.

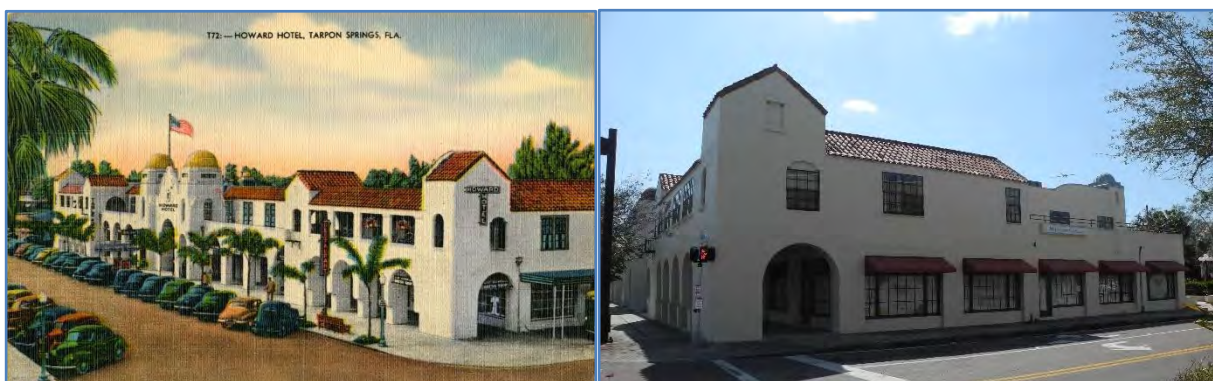
Figure 14. Tarpon (Shaw) Arcade historic 1948 post card (left – billed as the “Howard Hotel”) <https://www.floridamemory.com/items/show/334314>) and current 2022 photo (right).

- The Tarpon (Shaw) Arcade (FMSF #8Pi1870), built in 1925 in the Mediterranean Revival Style, represents the Florida Land Boom period (Figure 14). The building is of masonry construction and has a first-floor slab on grade that is slightly elevated above the adjacent sidewalk ([NR#84000943](#), listed 1984).
- The Tarpon Springs Old City Hall (FMSF #8Pi1578) is now the Tarpon Springs Cultural Center. The Old City Hall was built from brick masonry construction in the Neo-Classical Revival style in 1915 and is a significant structure in the heart of the commercial center of the City ([NR#90001117](#), listed 1990).

Unreinforced masonry construction was typical of pre-1945 structures, and consists of masonry units mortared together to form bearing and non-bearing walls. Unreinforced masonry is a bit of a misnomer, as there may be minimal amounts of metal bars or sections used for reinforcement in the walls, depending on the skill of the mason and the size and complexity of the structure. If any reinforcement was used, it was usually placed in lintels over large wall openings, sometimes in the perimeter beam at the top of the wall, on intersecting corners, and occasionally as vertical rods spaced along the length of the masonry walls. These intermittent reinforcements were focused on strengthening individual features of the building and did not create an overall structural load path intended to hold the building together. Types of unreinforced masonry construction include stamped, patterned concrete block often made locally, and, hollow clay tile such as that used in the Tarpon Arcade building (Figure 14).

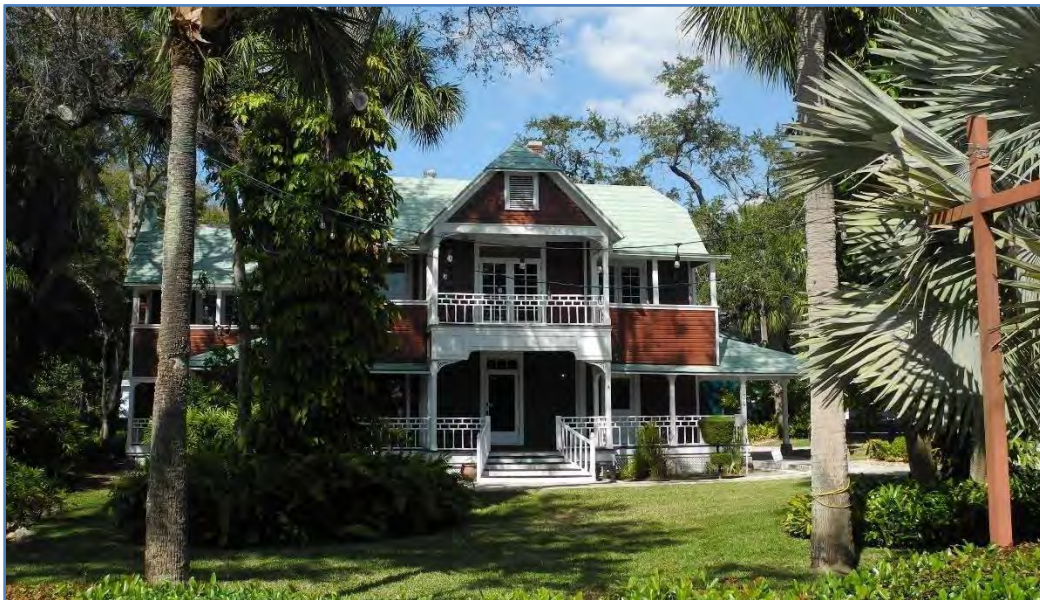
Frame Vernacular buildings (Figure 15) represent some of the earliest structures in Tarpon Springs, many dating from before 1915. These structures are typically built with elevated, wood-framed first floors over crawl spaces with simple brick piers supporting the floor system. Intervening spaces were left open or filled in with wood lattice work or framing. Some later alterations may have included replacing piers with solid masonry foundation walls.

Figure 15. Frame Vernacular style house on crawl space with lattice infill, 2022 photo.

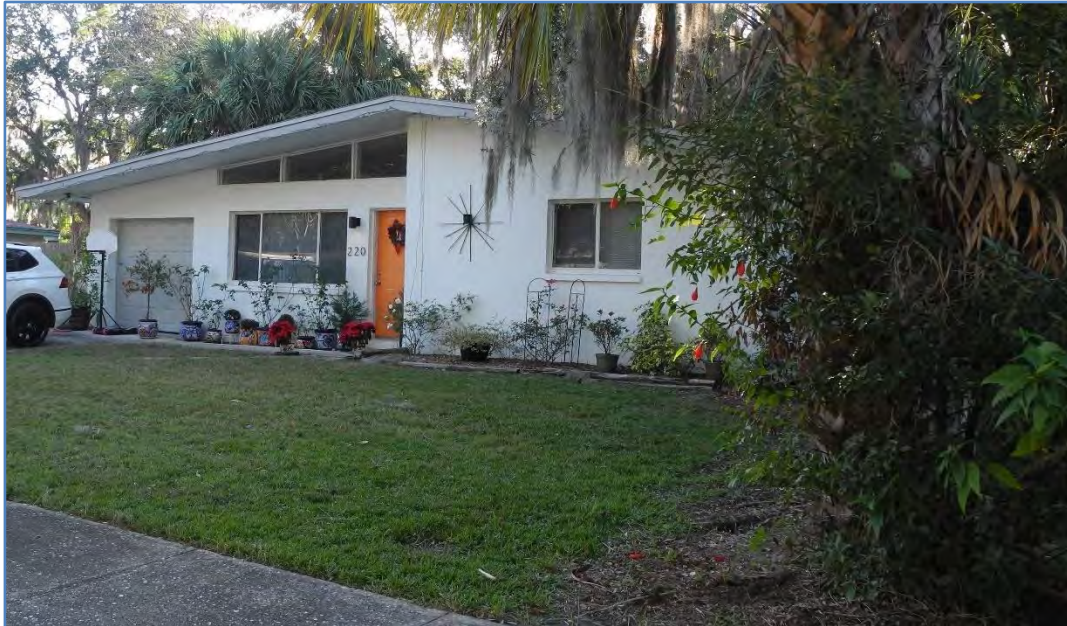
systems elevated on ventilated crawl spaces, similar to the all wood-frame construction systems seen in Bungalows or Frame Vernacular buildings. Most post-1950 structures are built with concrete slab floors on compacted fill at a level slightly above the adjacent grade level (Figure 16).

Figure 16. Typical midcentury modern masonry home with slab-on-fill system, 2022 photo.

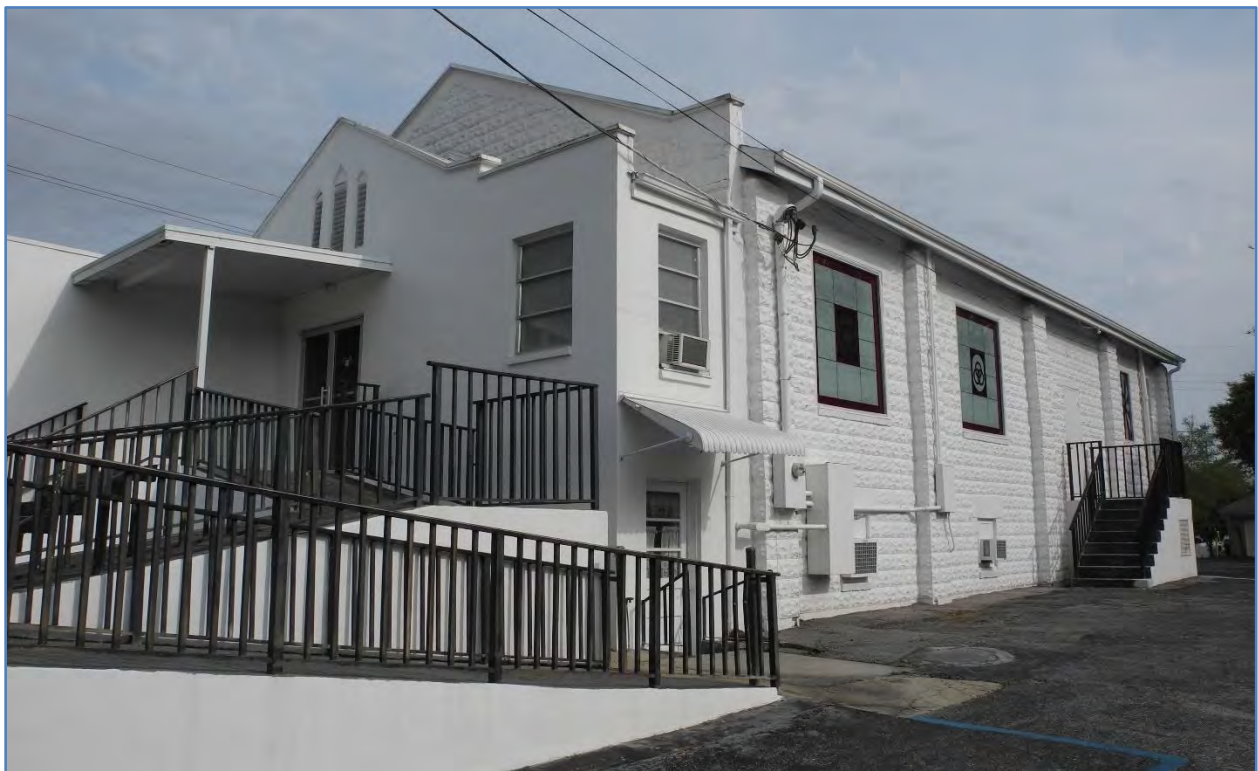
There are notable churches in the area that have special community significance, including the Macedonia Missionary Baptist Church (ca. 1948) at 448 East Oakwood Street (Figure 23), built with cast masonry blocks, with a front addition of stucco-covered masonry. The Rose Hill Cemetery is located east of U.S. Highway 19 outside the Union Academy neighborhood but has special significance as the historic African-American cemetery in the City. That cemetery is listed on the **National Register of Historic Places** (NR#100000711).

Figure 23. Macedonia Missionary Baptist Church, built in 1948, 2022 photo.

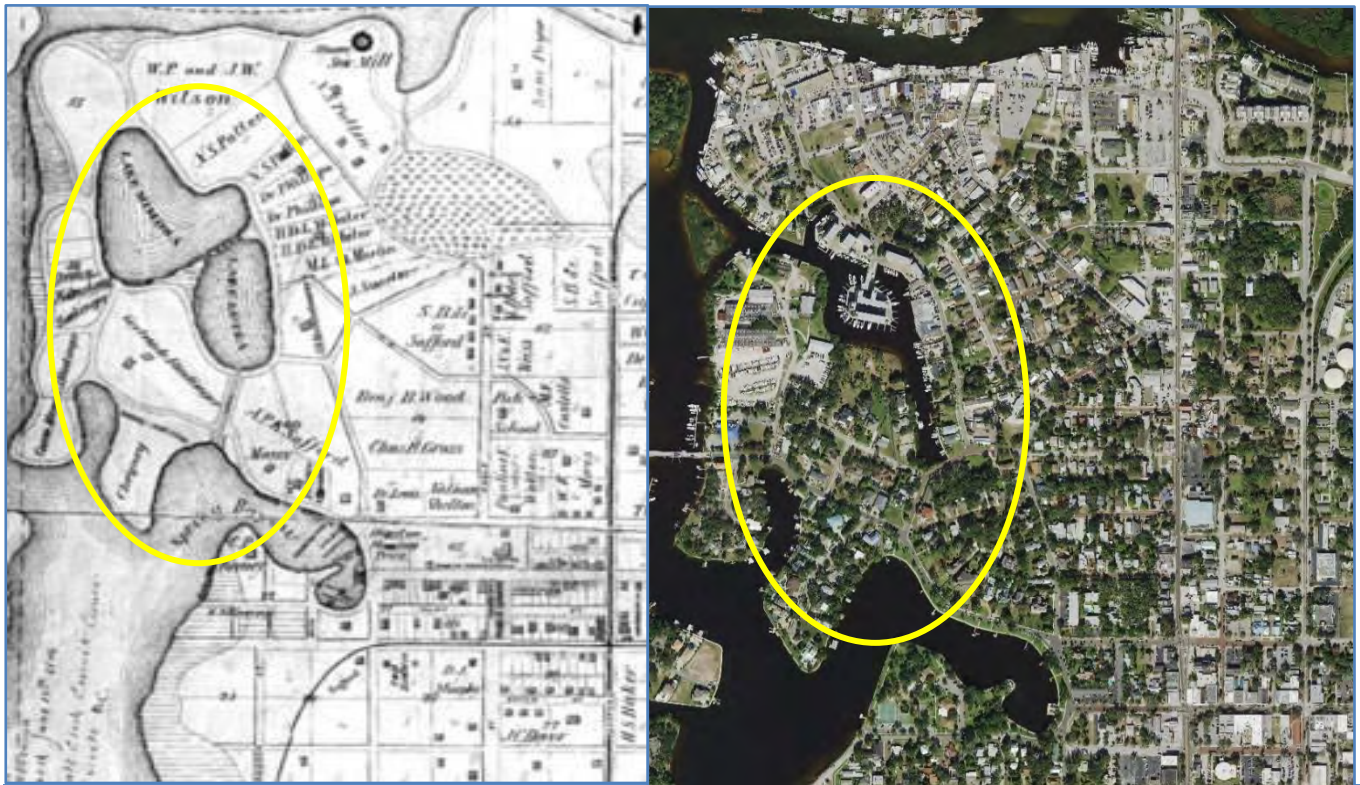
Figure 24. 1883 plat map of Tarpon Springs showing earlier configuration of Spring Bayou and connected lakes in the area now known as “The Canal” (State Archives of Florida, Florida Memory accessed July 1, 2022 <<https://www.floridamemory.com/items/show/5305>>).

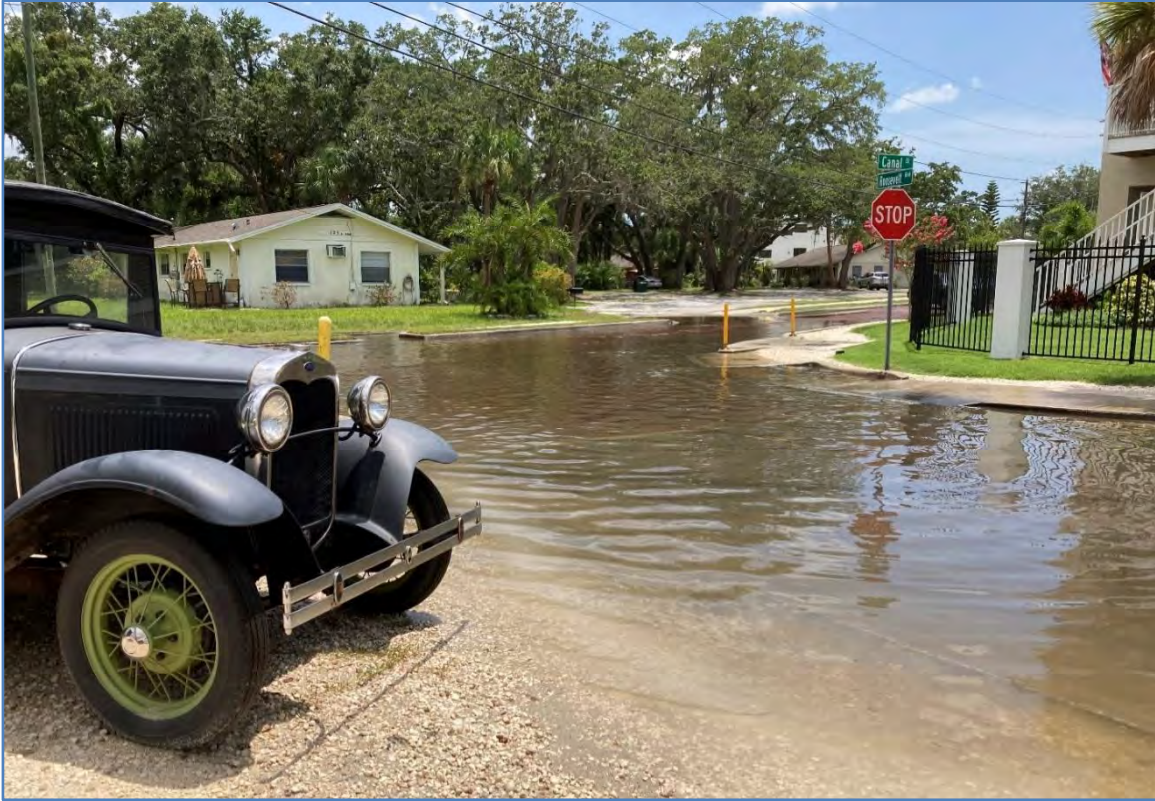
Figure 25. “Sunny day” flooding at Canal Street and Roosevelt Boulevard intersection, full moon high tide, June 16, 2022.

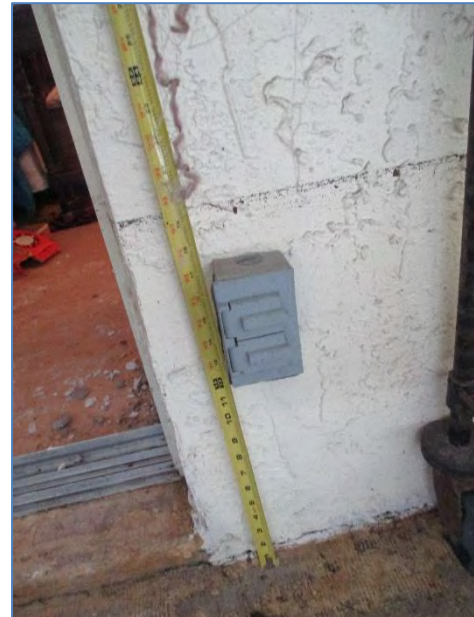
Figure 36. Twenty inches of floodwater covered electrical outlets at this mid-century slab on grade residence during a Category 1 hurricane (2016 photo).

- one foot of **floodwater** will affect piers but may stay below the floor levels,
- two feet of flood water will affect the piers and floor, and,
- three feet of flood water will affect piers, floor, walls, and interior/exterior infrastructure such as electrical outlets (Figure 36).

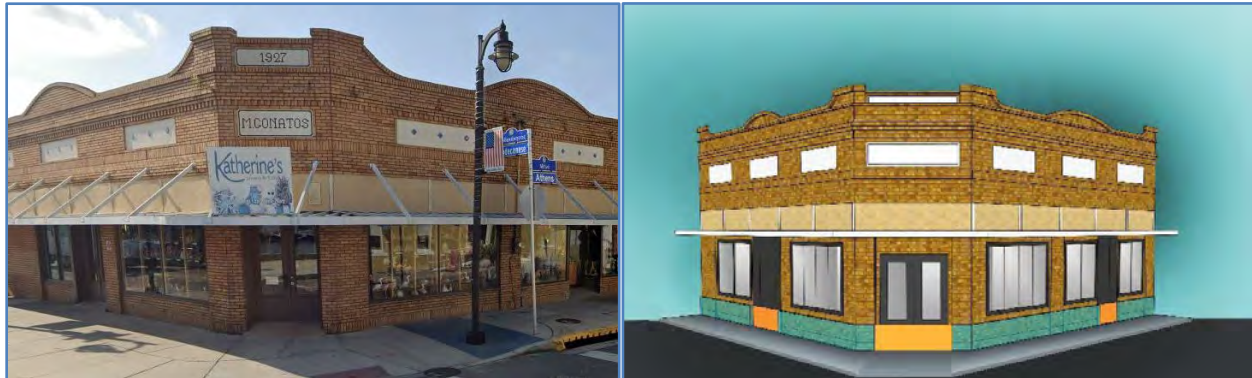
Figure 37. Temporary protective measures using floodgates and flood-wrapping for single story commercial: Gonatos Building, 628 Athens Street.

The Gonatos building (ca. 1927) located at the corner of Dodecanese Boulevard and Athens Street is typical of masonry commercial structures with finished floors below the **base flood elevation** (Figure 37). This roadway intersection floods, sometimes heavily, from **storm surge**, rainfall and high tide events. Installing **floodgates at the entry ways, and temporary flood-wrapping** of these single story shops is a good way to implement flood mitigation, while causing little impact on the aesthetics of the architectural elements.

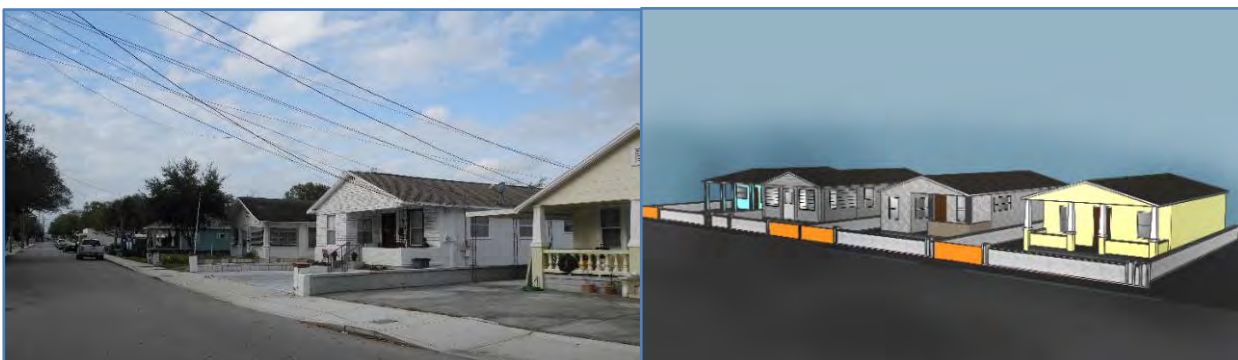
Figure 40. Streetscape at 120-126 Athens Street, illustrating potential coordinated protection using permanent garden walls and floodgates.

Several homes along the streetscape at 120-126 Athens Street have existing low masonry **site walls or garden walls** (Figure 40). These can be enhanced for flood protection by extending the permanent garden walls along the streetscape and designing them to allow for the insertion of temporary **floodgates** where they intersect with driveways and walkways. Most property grades being higher than the street, this will act as a first “line of defense” as flood waters fill the street before encroaching onto the properties.

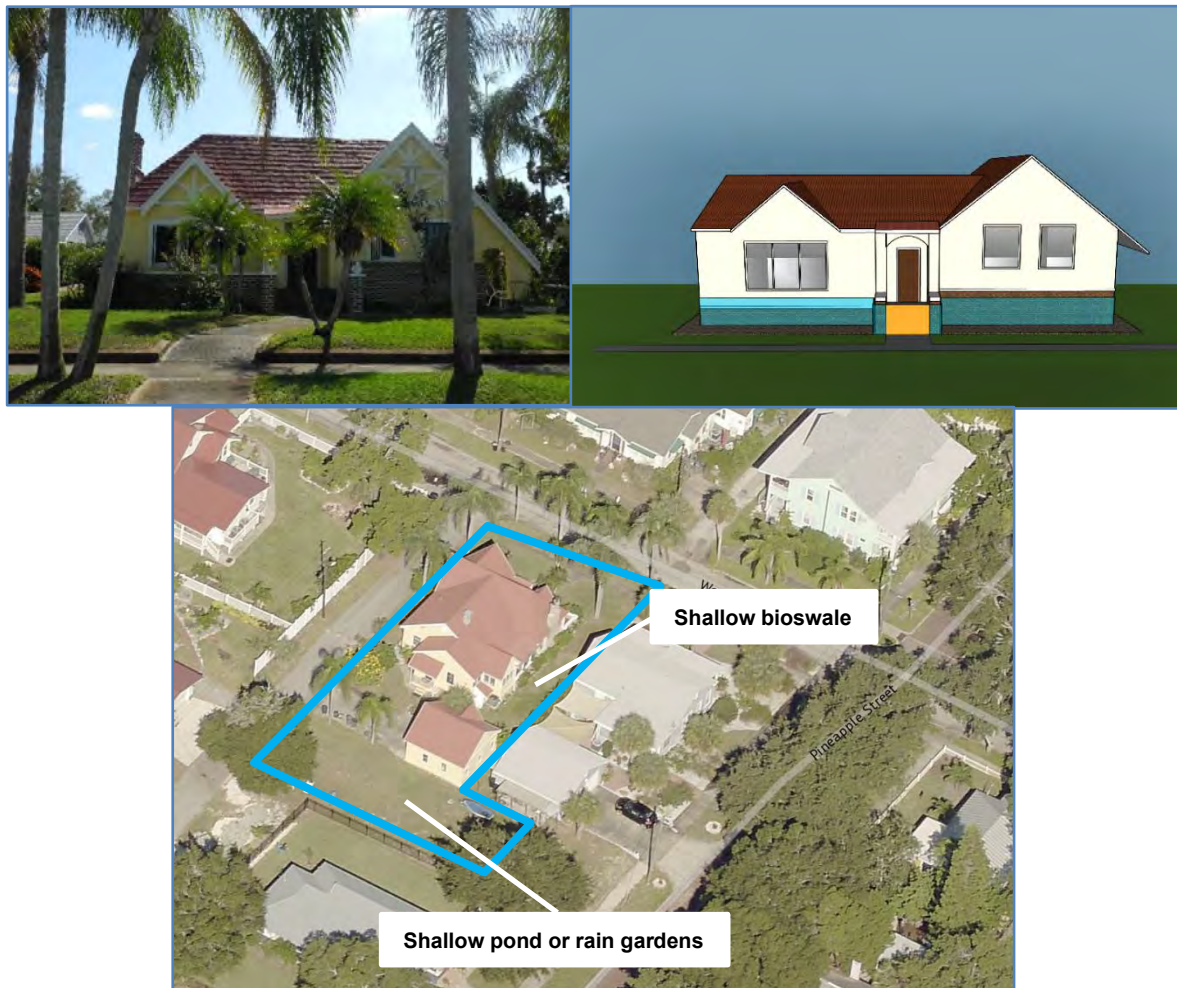
Figure 41. Residence at 409 West Lemon Street, illustrating potential coordinated protection using landscape adaptations and flood-wrapping (blue line indicates approximate property line).

The residence at 409 West Lemon (Figure 41) is constructed of brick and stucco. Due to the home being built in the early 1920's the brick mortar is most likely of natural hydraulic lime. In this case, **temporary flood-wrapping** and barriers could protect the brick from rising waters. This property is large enough to incorporate **landscape mitigation measures** such as **vegetated bioswales** and **rain gardens**, or shallow ponds and grading. These features could help redirect and hold water before it gets to the primary structure, especially during significant rainfalls.

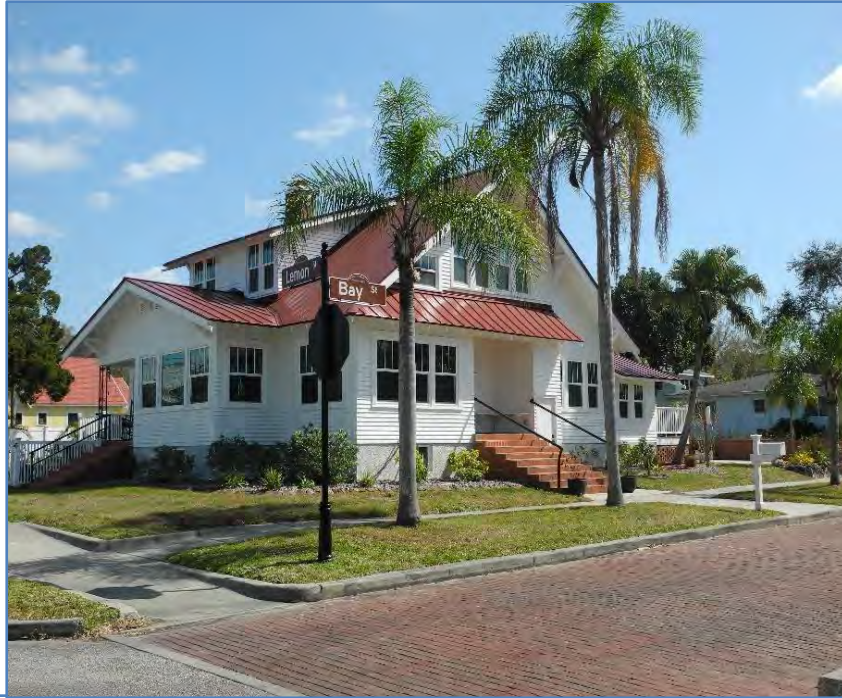
Figure 43. The home at 201 Bay Street is elevated on a continuous brick foundation wall and includes a basement. The elevation well above grade is emphasized by the long staircases leading into the front and sides of the structure.

The home located at 201 Bay Street (Figure 43) is an excellent example of a home that has already been elevated, with adequate setback to allow for a longer stairway approach to soften the historic visual impact.

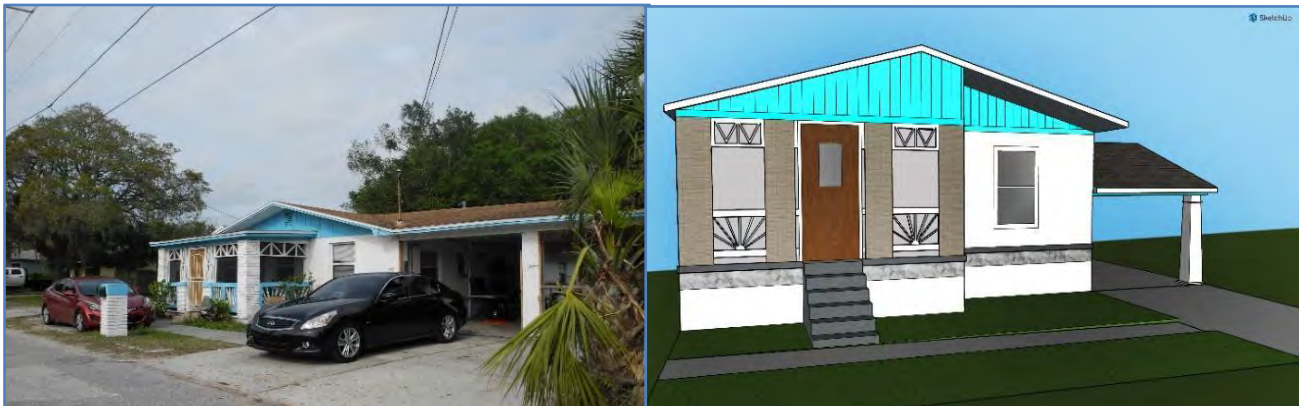
Figure 44. A slab on grade residence in the Union Academy neighborhood could potentially be elevated on foundation walls to the design flood elevation.

For single story homes in **floodplains**, such as the slab on **grade** residence shown in Figure 44, it is recommended to elevate the home to the minimum required to be compliant with the FEMA **design flood elevation** if no other barrier method is appropriate or possible. In this case, the living area is elevated while the carport remains at **grade**. Disruption of the **architectural style**

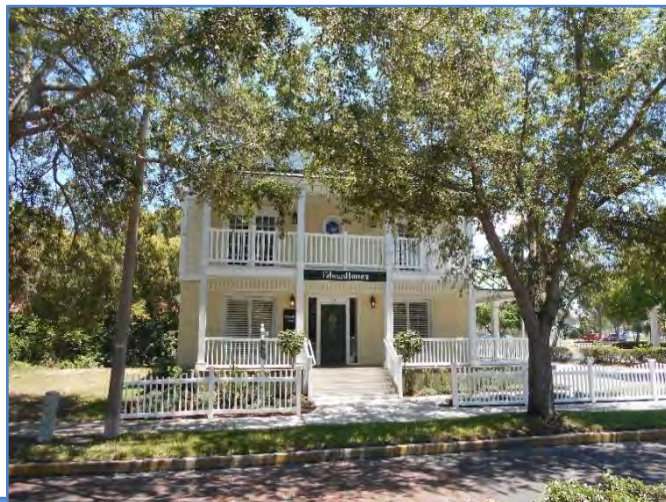
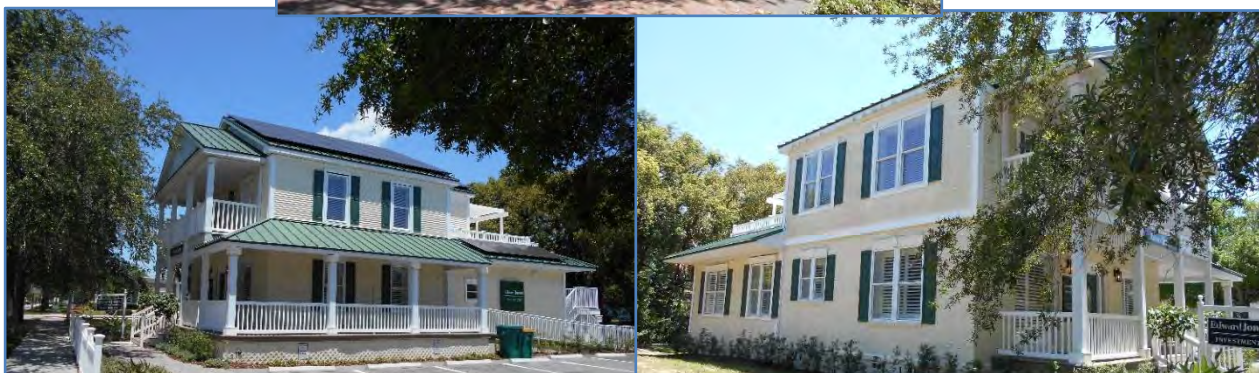
Figure 49. The office of Edward Jones financial advisors is an adaptive reuse of a residential structure (ca. 1936) that was moved in 2001 from the AE Flood Zone to North Safford Avenue, outside the floodplain. Note the landscaping and low-rise steps that soften the building's new foundation.

Moving a historic building requires separating the building from its foundation and relocating it to a new site and foundation. The new site would ideally be outside a **flood zone**, or the new foundation would raise the building above the expected **flood elevation** (but see *Elevate the Building on a New Foundation*, above). The building must be strong enough to withstand the travel required to relocate it, as in the case of the house located at 22 North Safford Avenue (Figure 49). This residential structure that has been adapted to office space was relocated outside the **floodplain** from its original location in the **AE Flood Zone**. The building consists of a mix of construction materials (frame and block/brick) with walls of approximately 11 inches in thickness (Robin Hancock, pers. comm.). The purpose of the relocation in this case was to make way for commercial development on the original parcel, but a major benefit of the move was relocation to an appropriate historical setting in the City's downtown outside the **floodplain**. Moving a building is physically and financially challenging. In Tarpon Springs, much of the City is in the **floodplain**, so appropriate sites that remove or reduce a building's exposure to flood risk are limited.
